NA 4600

EVERColor™ PQ

GROUT
TROUBLESHOOTING
GUIDE

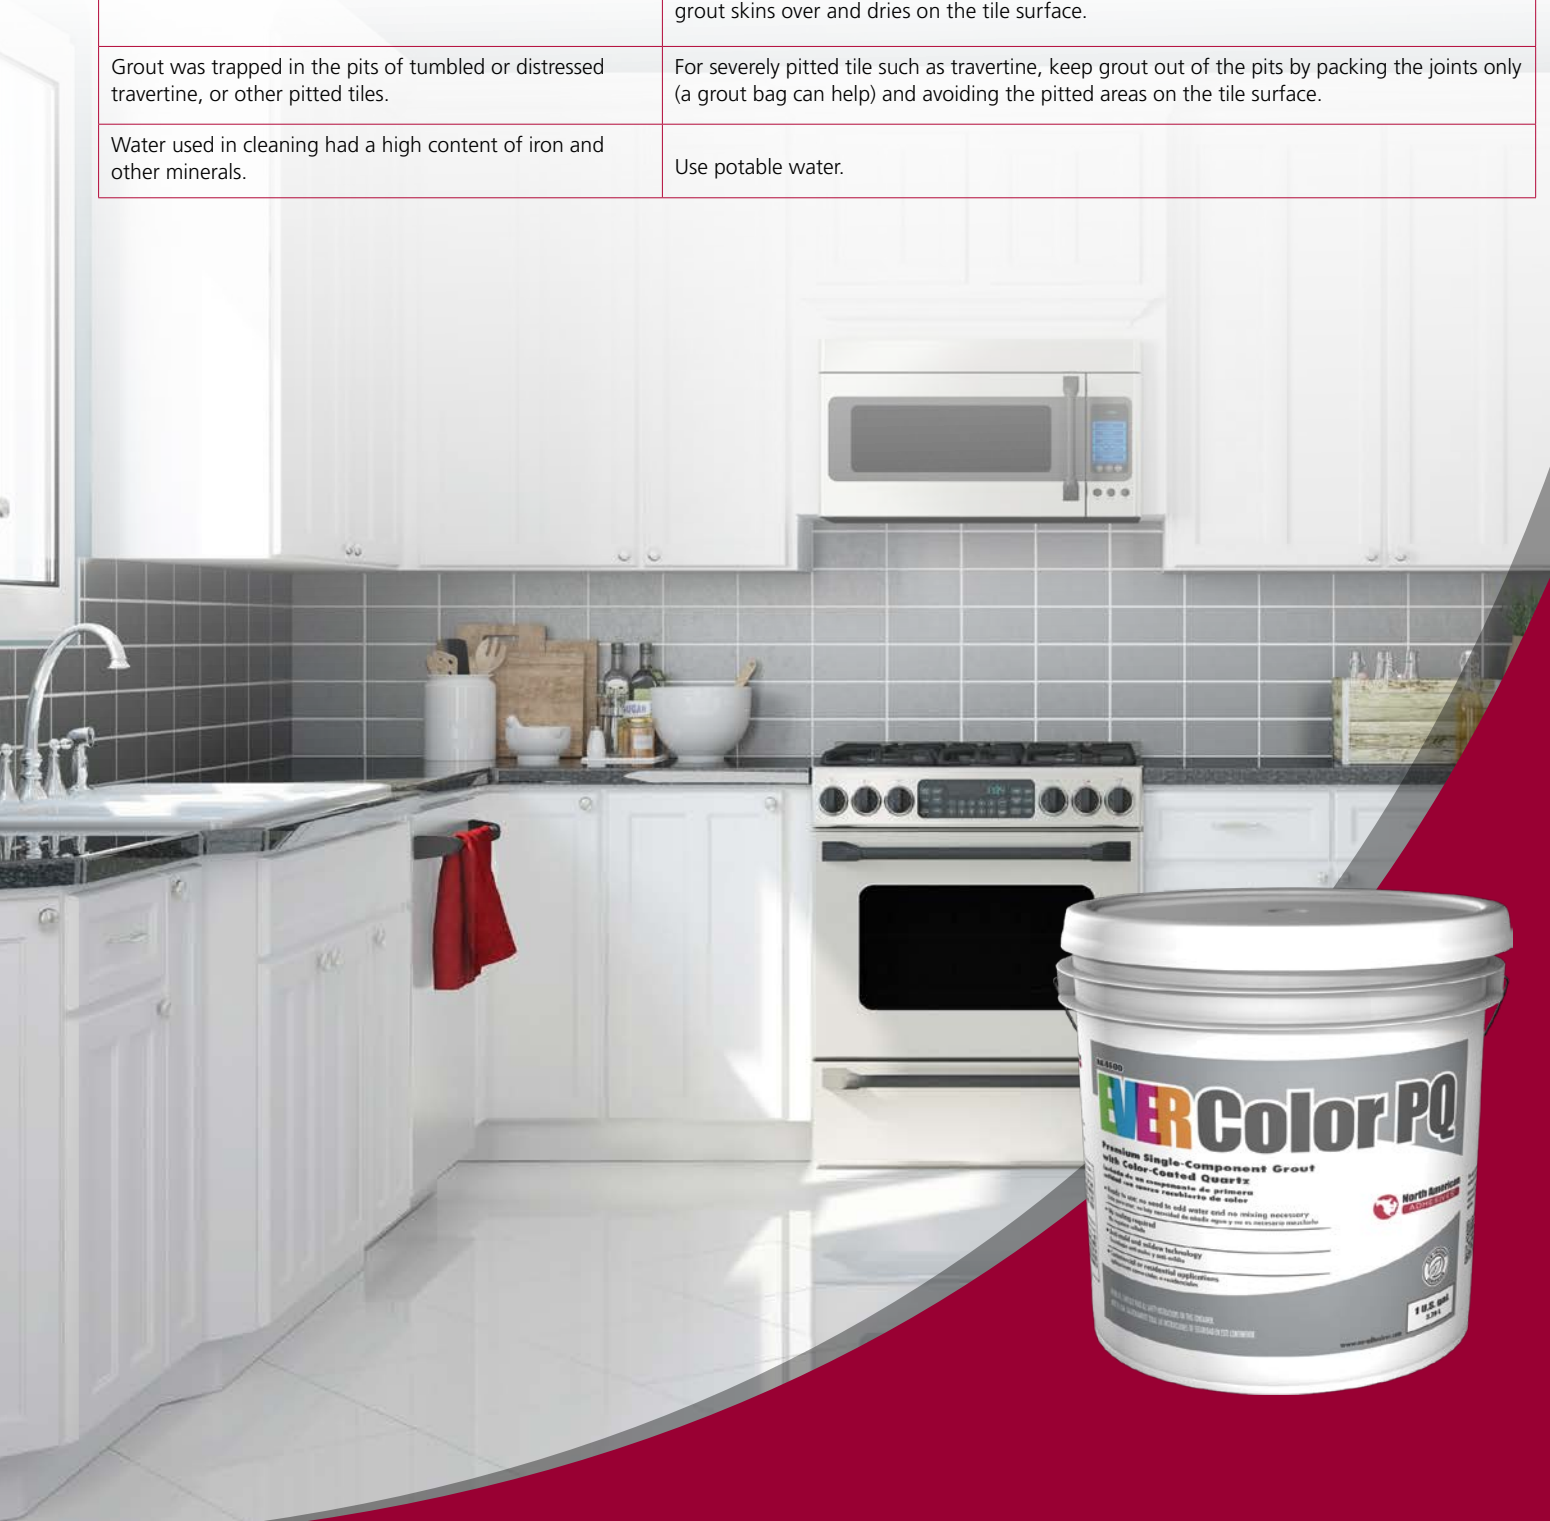
Tile discoloration

A non-uniform hazy, filmy, shaded or dirty appearance on the **tile surface** that can be caused by several factors

Sources	Solutions
Grout haze was present on the tile surface after grouting because cleaning was not completed early enough.	Typically, 5 to 10 minutes (10 to 15 sq. ft. [0.9 to 1.39 m ²]) of grouting is recommended before doing an initial wash. Temperature and humidity conditions can impact this recommendation. Window cleaner and a scrub pad can remove light haze; heavier haze will benefit from an adhesive remover.
Jobsite conditions – such as direct sun exposure, hot ambient or tile temperatures, or too much area being grouted at one time before the cleanup process begins	Protect tilework from direct sun during application, and always apply within the temperature ranges of the current Technical Data Sheet (TDS). Grout small areas of 10 to 15 sq. ft. (0.9 to 1.39 m ²) at a time, so that cleaning can begin before the grout skins over and dries on the tile surface.
Grout was trapped in the pits of tumbled or distressed travertine, or other pitted tiles.	For severely pitted tile such as travertine, keep grout out of the pits by packing the joints only (a grout bag can help) and avoiding the pitted areas on the tile surface.

Water used in cleaning had a high content of iron and other minerals.	Use potable water.

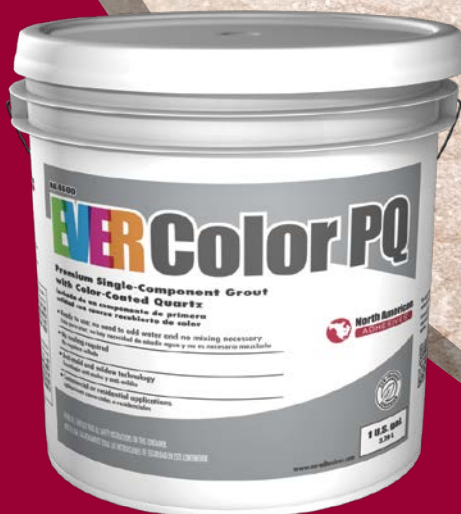
Grout with **pinholes**

Very small holes – typically the size of a pinhead or less – that appear in the grout joint

Sources	Solutions
Too much water was used during the cleaning process.	Use a sponge slightly moistened but without water dripping out. Follow recommended product application procedures on the product label and Technical Data Sheet (TDS).
Grout was not correctly forced into the joints.	<i>NA 4600 Ever Color PQ</i> grout should be floated with a medium- to hard-rubber float at a 45-degree angle to the tile surface. Excessive grout should be removed using the float at a 90-degree angle from the tile surface, moving diagonally to the joints.
